# Rocky Flats Environmental Technology Site

# RECONNAISSANCE LEVEL CHARACTERIZATION REPORT (RLCR)

## **GROUP 11 AND GROUP 15 CLOSURE PROJECTS**

B850, B890, 881C (CT2, South Tower and CT3, East Tower), 883C (881CT4, North Tower), 881G, 881H, C-865 and T690N; and T891D, T891E, T891F, T893A, T893B, T900E and T904A

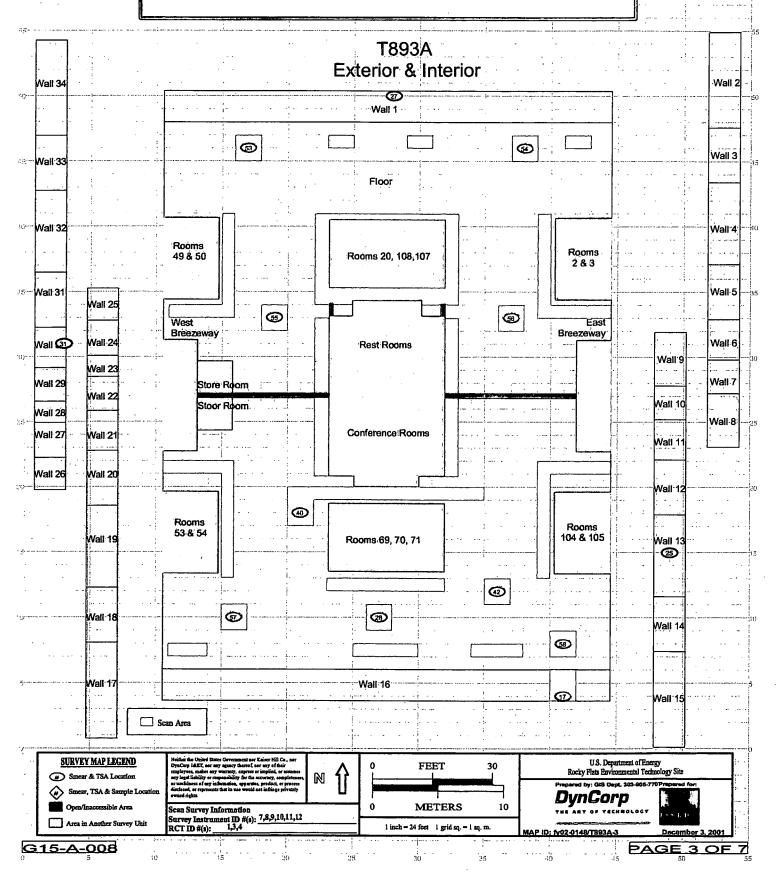
Survey Area: A Survey Unit: G15-A-tiu8 Classification: T893A
Survey Unit Description: Interior & Exterior Total Roof Area: 1467 sq. m.

Total Floor Area: 1424 sq. m.

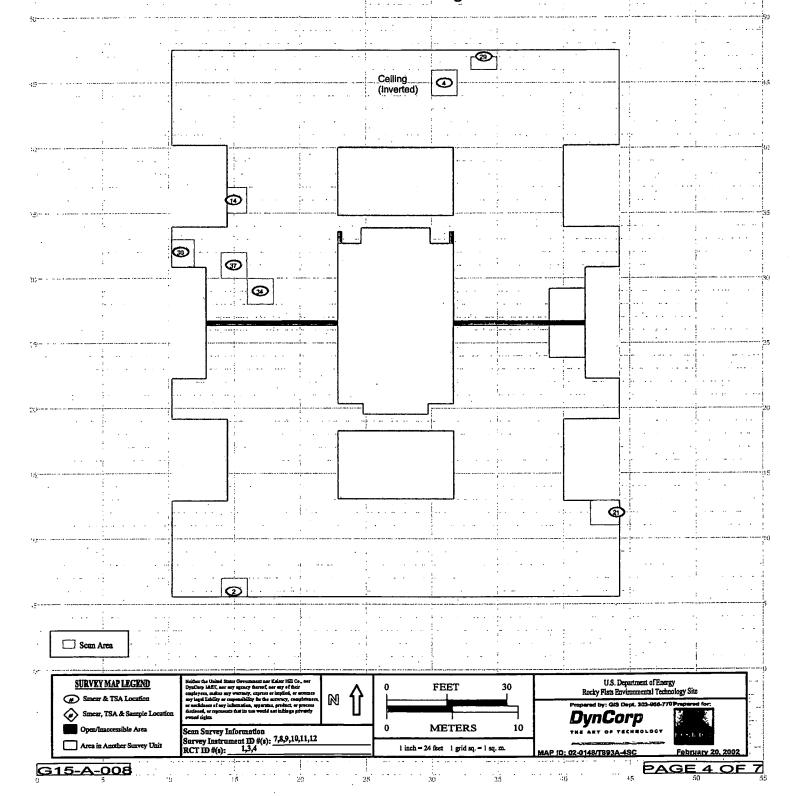
T893A Interior ceiling

Survey Unit Description: Interior & Exterior
Total Area: 6764 sq. m.
Total Floor Area: 1467 sq. m.
Total Floor Area: 1424 sq. m.

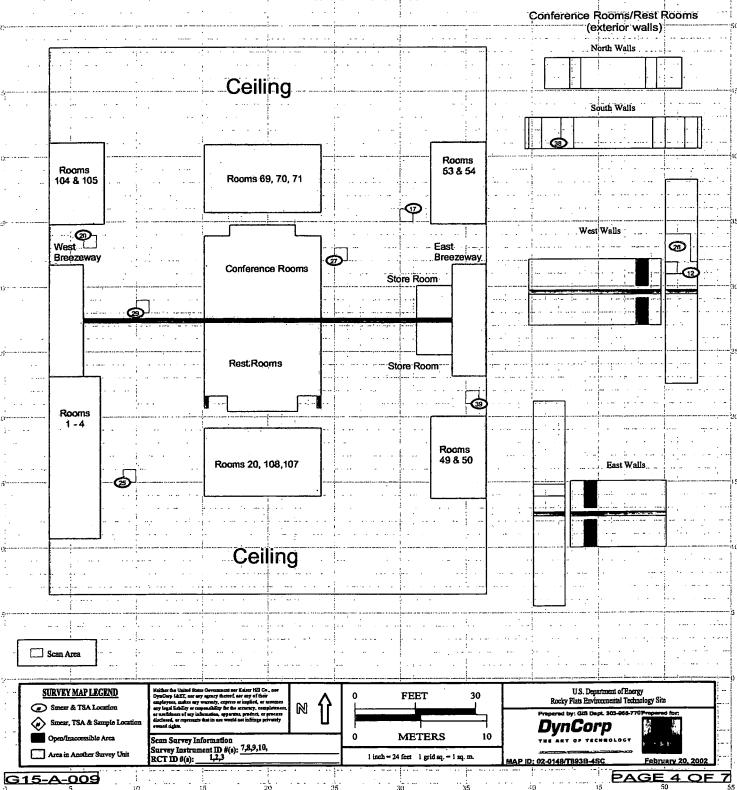
# T893B Interior

Survey Unit: G15-A-009 Classification: 3
Total Roof Area: 1467 sq. m.
Total Floor Area: 1389 sq. m.

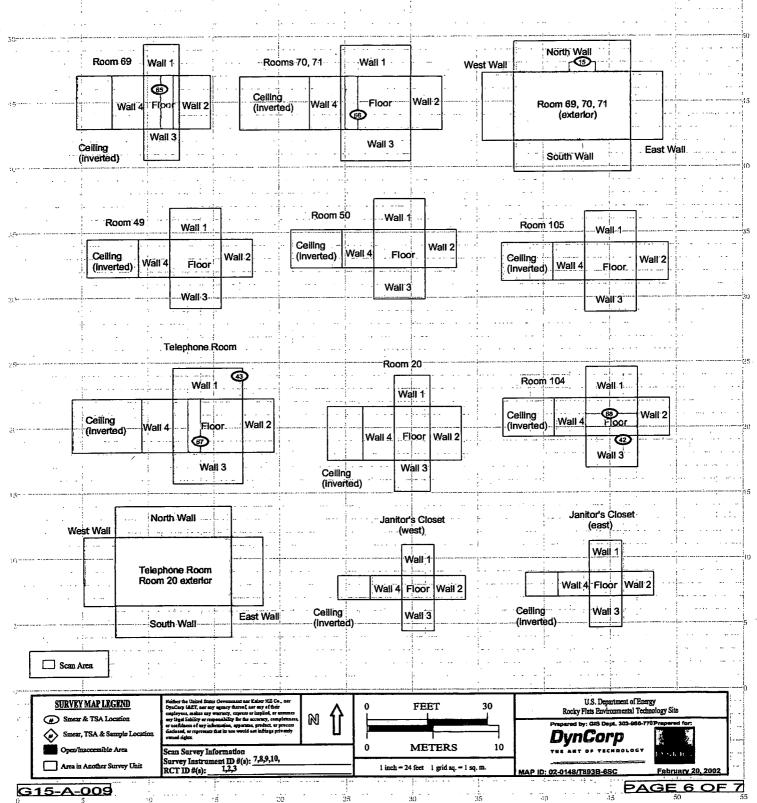
T893B Interior

Total Floor Area: 1389 sq. m.
